**Flood Control Project Maintenance
Levee Inspections**

Maintenance Issue Types Only, Levee Inspection Report By Mile - Spring 2018

Reclamation District No. 2091 Chase

Waterway	Bank	Unit Miles	Inspection Start/End	Inspector
Unit No. 01 San Joaquin River	Right	7.46	05/01/2018 05/01/2018	Richard Willoughby

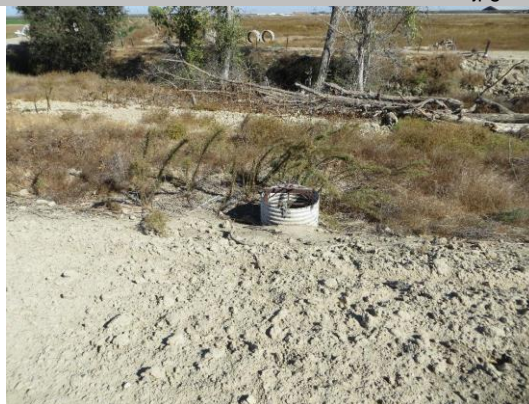
Photo 1 of 3 : UCIP_SP_2018_43207_38148.jpg

LM Start	0.08	Rating **	M	Issue No.	45
LM End	0.08	Issue Type +	Ma	Location *	
Category	Supplemental			GPS Latitude/Longitude	
				Start	End
Item	DWR UCIP LMA Responsibility			37.541970 °	37.541970 °
				-121.093980 °	-121.093980 °
DWR ID					
Comment Code					
Inspector Comment					
FS_ID:43207 DS_ID:23155 EP_NO: N/A Repair Type: Non-Urgent Crossing Status: Found UCIP Comments: Appears abandoned and if so should be done so properly. FIELD_STRUCT_DESC: *ABANDONED* 24-inch corrugated metal drainage pipe through the levee, 7.2 feet below the crown. Slide gate in a 36-inch corrugated metal pipe (CMP) riser on the waterside (WS) slope. [Additional Reference(s): DWR Levee Log, 1992. USACE San Joaquin O&M Manual 6, September 1961, (HLM 0.07), Drawing No. 07-04-1555, Sheets 1555/17 and 1555/55, (Station 906+85)]. FS Date: 1/29/2015 2:26:31 PM

Slide gate in 36-inch CMP riser on WS toe.

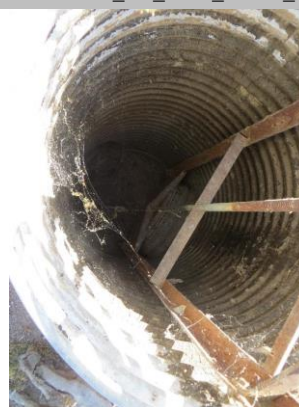
Photo 2 of 3 : UCIP_SP_2018_43207_38147.jpg

Slide gate in 36-inch CMP riser on WS toe.

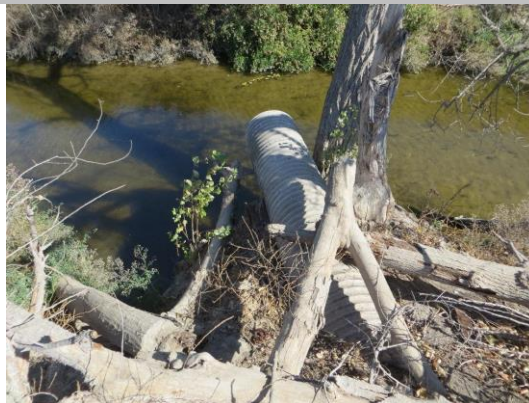
Photo 3 of 3 : UCIP_SP_2018_43207_38146.jpg

LM Start	0.08	Rating **	M	Issue No.	45 (cont)	
LM End	0.08	Issue Type +	Ma	Location *		
Category	Supplemental			GPS Latitude/Longitude		
				Start		End
Item	DWR UCIP LMA Responsibility			37.541970 °		37.541970 °
				-121.093980 °		-121.093980 °
DWR ID						
Comment Code						
Inspector Comment						
FS_ID:43207 DS_ID:23155 EP_NO: N/A Repair Type: Non-Urgent Crossing Status: Found UCIP Comments: Appears abandoned and if so should be done so properly. FIELD_STRUCT_DESC: *ABANDONED* 24-inch corrugated metal drainage pipe through the levee, 7.2 feet below the crown. Slide gate in a 36-inch corrugated metal pipe (CMP) riser on the waterside (WS) slope. [Additional Reference(s): DWR Levee Log, 1992. USACE San Joaquin O&M Manual 6, September 1961, (HLM 0.07), Drawing No. 07-04-1555, Sheets 1555/17 and 1555/55, (Station 906+85)]. FS Date: 1/29/2015 2:26:31 PM

CMP stormdrain at outlet off WS toe.

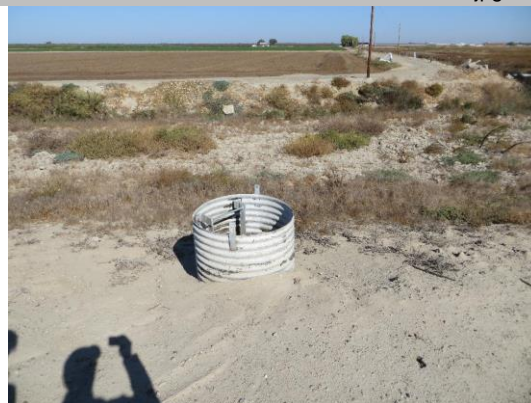
Photo 1 of 3 : UCIP_SP_2018_51387_38150.jpg

FS_ID:51387
DS_ID:23156
EP_NO: N/A
Repair Type: Urgent
Crossing Status: Found
UCIP Comments: 11/18/2016 Same as last inspection this is a non-functional crossing with no visible inlet on LS or outlet on WS. The only appurtenance found at this location is a CMP riser with a missing cover located on the WS. This crossing remains Urgent since the pipe on the WS may still be opened. According to Mike Alves, this crossing is abandoned and the City of Modesto is working with CVFPB to authorize proper abandonment/removal. The City is working at finding funds to pay for proper abandonment/removal of all the drainage structures through this levee. (O. Magana - DWR UCIP)01/29/2015 Pipe open on WS and slide gate has been removed. Appears abandoned and should be done so properly. (M. Alves - City of Modesto)
FIELD_STRUCT_DESC: *ABANDONED* 24-inch corrugated metal drainage pipe through the levee, 9 feet below the crown. Slide gate in a corrugated metal pipe (CMP) riser located on the waterside (WS) slope.

36-inch CMP riser on WS slope.

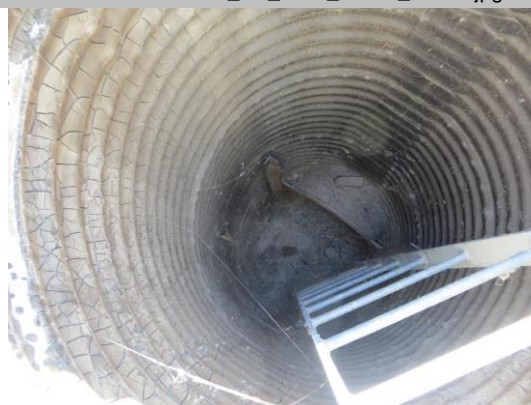
Photo 2 of 3 : UCIP_SP_2018_51387_38149.jpg

Slide gate missing from open end of pipe at WS slope.

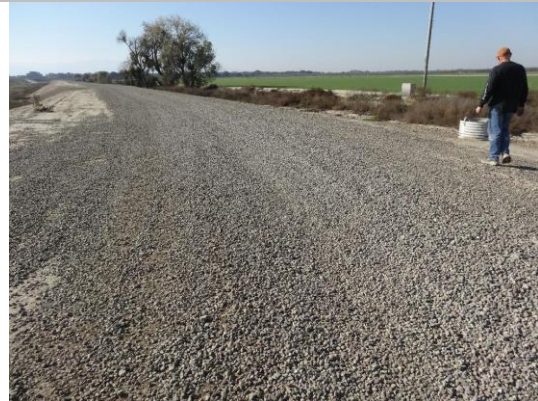
Photo 3 of 3 : UCIP_SP_2018_51387_76669.jpg

FS_ID:51387
DS_ID:23156
EP_NO: N/A
Repair Type: Urgent
Crossing Status: Found
UCIP Comments: 11/18/2016 Same as last inspection this is a non-functional crossing with no visible inlet on LS or outlet on WS. The only appurtenance found at this location is a CMP riser with a missing cover located on the WS. This crossing remains Urgent since the pipe on the WS may still be opened. According to Mike Alves, this crossing is abandoned and the City of Modesto is working with CVFPB to authorize proper abandonment/removal. The City is working at finding funds to pay for proper abandonment/removal of all the drainage structures through this levee. (O. Magana - DWR UCIP)01/29/2015 Pipe open on WS and slide gate has been removed. Appears abandoned and should be done so properly. (M. Alves - City of Modesto)
FIELD_STRUCT_DESC: *ABANDONED* 24-inch corrugated metal drainage pipe through the levee, 9 feet below the crown. Slide gate in a corrugated metal pipe (CMP) riser located on the waterside (WS) slope. [Additional Reference(s): DWR Levee Log, 1992. USACE San Joaquin O&M Manual 6, September 1961, (HLM 0.10), Drawing No. 07-04-1555, Sheets 1555/17 and 1555/55, (Station 907+55)].

Overview of levee crown at pipe crossing.

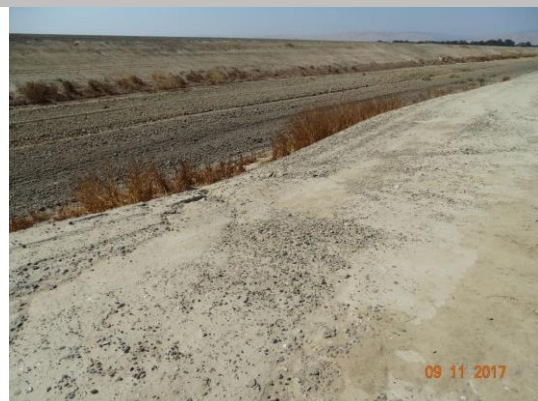
Photo 1 of 2 : SP_2018_RD2091_318_15_20180307_00015.jpg

Caving on landward shoulder possible collapsed pipe. Caving is 34 feet long over one inch depth.

Looking southwest at the dip on the landside shoulder.

E1 : Note and monitor erosion site.

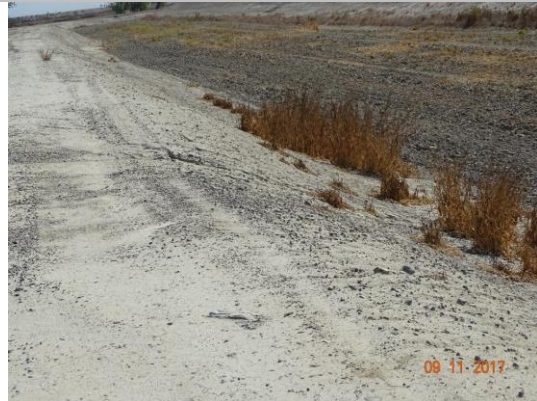
Photo 2 of 2 : SP_2018_RD2091_318_15_20180307_00016.jpg

LM Start	0.23	Rating **	M	Issue No.	15 (cont)	
LM End	0.23	Issue Type +	Ma	Location *	LS	
Category	Earthen Levee			GPS Latitude/Longitude		
				Start	End	
Item	Erosion / Bank Caving			37.541550 °	37.541550 °	
				-121.096742 °	-121.096742 °	
DWR ID	DWR_RD2091_01_s_2016_15					
Comment Code						
E1 : Note and monitor erosion site.						
Inspector Comment						
Caving on landward shoulder possible collapsed pipe. Caving is 34 feet long over one inch depth.

Looking northeast at the dip in the landside shoulder.

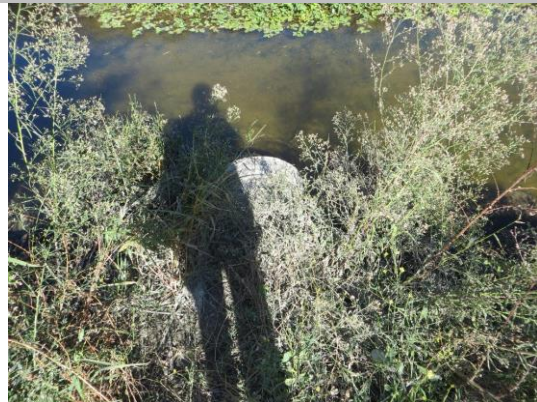
Photo 1 of 3 : UCIP_SP_2018_51388_38156.jpg

Comment Code					
Inspector Comment					
FS_ID:51388 DS_ID:23158 EP_NO: N/A Repair Type: Urgent Crossing Status: Found UCIP Comments: 11/18/2016 Same as last inspection. This crossing remains Urgent due to the flap gate still missing from the WS toe. According to Mike A. this crossing is an abandoned line and the City of Modesto is working with CVFPB to authorize proper abandonment/removal. The City is working at finding funds to pay for proper abandonment/removal of all the drainage structures through this levee. (O. Magana - DWR UCIP)01/29/2015 Flap gate has fallen off at WS toe. Appears abandoned and if so should be done so properly. (M. Alves - City of Modesto) FIELD_STRUCT_DESC: *ABANDONED* 24-inch corrugated metal drainage pipe through the levee, 10 feet below the crown. Flap gate on the waterside (WS) end. Drain opening is located approximately 15 feet off the landside (LS) toe. [Additional Reference(s): DWR Levee Log, 1992. USACE San Joaquin O&M Manual 6, September 1961, (HLM 0.23), Drawing No. 07-04-1555, Sheets 1555/17 and 1555/55, (Station 915+00)]. FS Date: 11/18/2016

Pipe visible in canal on WS toe.

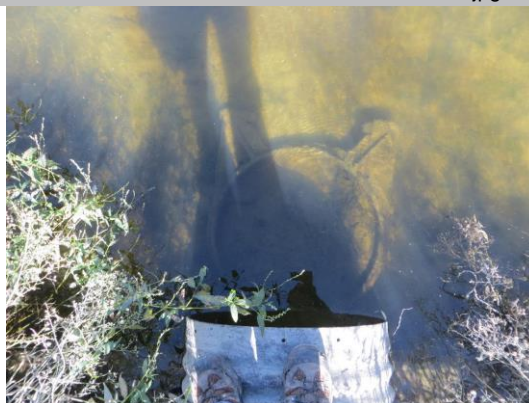
Photo 2 of 3 : UCIP_SP_2018_51388_38155.jpg

FS_ID:51388
DS_ID:23158
EP_NO: N/A
Repair Type: Urgent
Crossing Status: Found
UCIP Comments: 11/18/2016 Same as last inspection. This crossing remains Urgent due to the flap gate still missing from the WS toe.
According to Mike A. this crossing is an abandoned line and the City of Modesto is working with CVFPB to authorize proper abandonment/removal. The City is working at finding funds to pay for proper abandonment/removal of all the drainage structures through this levee. (O. Magana - DWR UCIP)01/29/2015 Flap gate has fallen off at WS toe. Appears abandoned and if so should be done so properly. (M. Alves - City of Modesto)
FIELD_STRUCT_DESC: *ABANDONED* 24-inch corrugated metal drainage pipe through the levee, 10 feet below the crown. Flap gate on the waterside (WS) end. Drain opening is located approximately 15 feet off the landside (LS) toe. [Additional Reference(s): DWR Levee Log, 1992. USACE San Joaquin O&M Manual 6, September 1961, (HLM 0.23), Drawing No. 07-04-1555, Sheets 1555/17 and 1555/55, (Station 915+00)].

Flapgate has fallen off at WS toe.

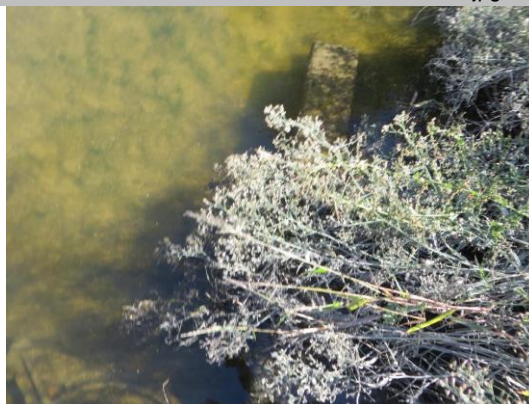
Photo 3 of 3 : UCIP_SP_2018_51388_38154.jpg

Concrete headwall under pipe at WS toe.

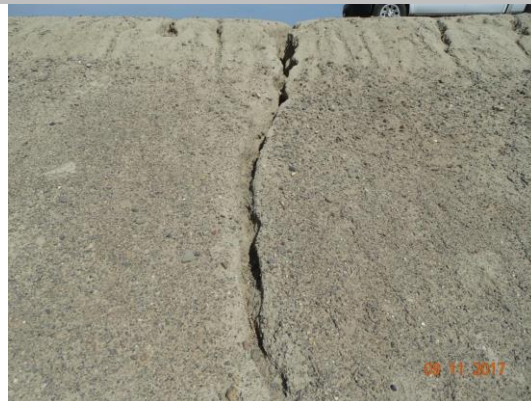
Photo 1 of 2 : SP_2018_RD2091_318_16_20180307_00017.jpg

Looking northwest at rill erosion on landside slope.

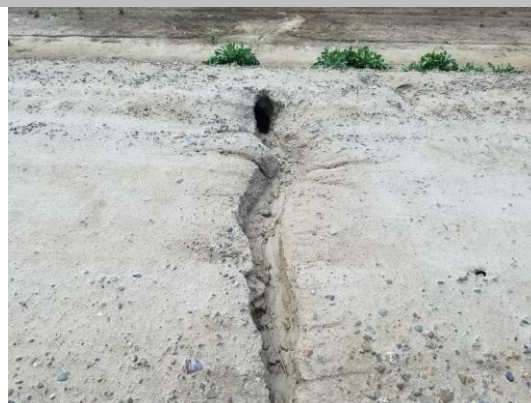
Photo 2 of 2 : SP_2018_RD2091_318_16_20180307_00018.jpg

Looking east at rill erosion above rodent hole on landward slope. (Spring 2017)

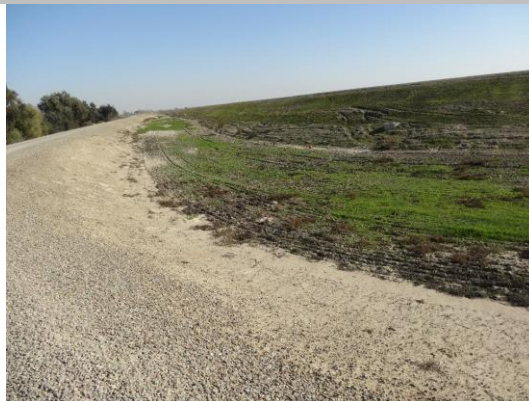
Photo 3 of 3 : UCIP_SP_2018_51639_76677.jpg

FS_ID:51639
DS_ID:23161
EP_NO: N/A
Repair Type: Non-Urgent
Crossing Status: Found
UCIP Comments: 11/18/2016 Crossing has been downgraded from Urgent to Non-Urgent since the flap gate appears to fully close. According to Mike Alvez, this crossing is abandoned and the City of Modesto is working with CVFPB to authorize proper abandonment/removal. The City is working at finding funds to pay for proper abandonment/removal of all the drainage structures through this levee. (O. Magana - DWR UCIP)01/29/2015 Appears abandoned and if so should be done so properly. (M. Alvez - City of Modesto)
FIELD_STRUCT_DESC: *ABANDONED* 24-inch corrugated metal drainage pipe through the levee, 12 feet below the crown. Flap gate and concrete headwall on the waterside (WS) end. [Additional Reference(s): DWR Levee Log, 1992. USACE San Joaquin O&M Manual 6, September 1961, (HLM 0.64)].
FS Date: 11/18/2016

View of LS.

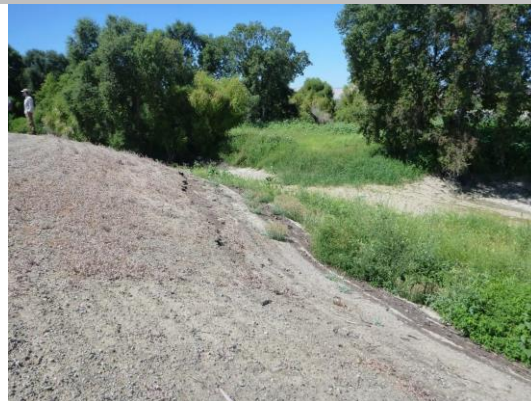
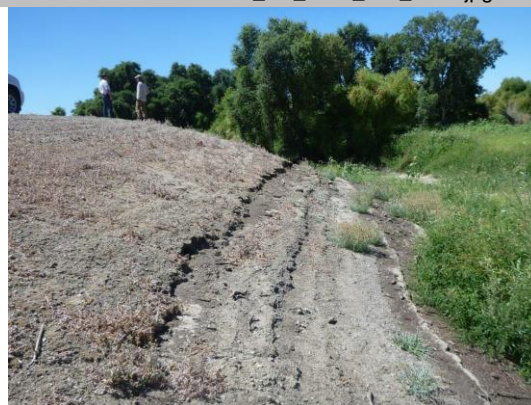
LM Start	0.94	Rating **	A/W	Issue No.	14
LM End	6.84	Issue Type +	Ma	Location *	
Category	Supplemental			GPS Latitude/Longitude	
				Start	End
Item	2017 Storm Damage			37.537775 °	37.482295 °
				-121.106730 °	-121.051592 °
DWR ID	DWR_RD2091_01_f_2017_14				
Comment Code					
Inspector Comment					
Levee Evaluation Comments					
Description:Wave wash damage/erosion of 2 miles ... see attached description and photos					
Site ID No:471					
Site Designation:LMA-298					
Repair Type: Erosion					
Rating:Area of Concern					
Field Date:7/20/2017					
Notes: Low priority because wavewash scarps are less than 1 ft and do not cut into prism significantly and can be repaired by district through O&M. There is also a large berm here. Wavewash is present on both LS and WS.

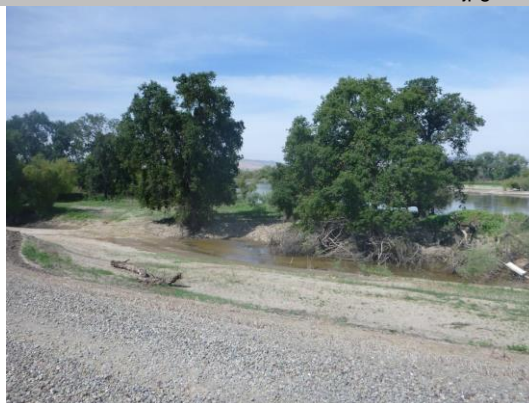
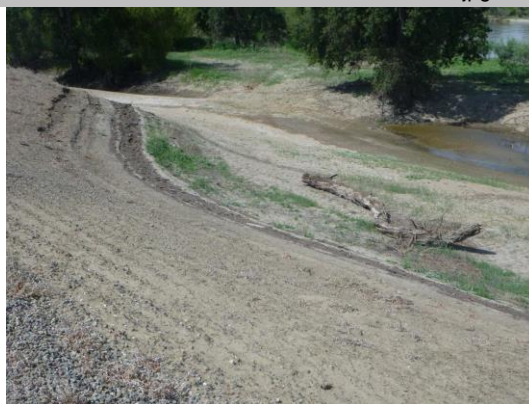
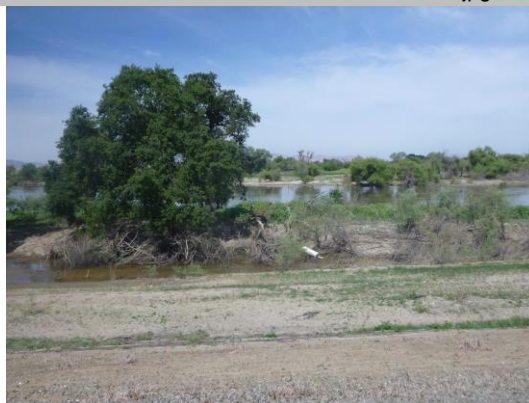
LM Start	1.41	Rating **	A/W	Issue No.	24	
LM End	1.44	Issue Type +	Ma	Location *		
Category	Supplemental			GPS Latitude/Longitude		
				Start	End	
Item	2017 Storm Damage			37.531170°	37.530760°	
				-121.106750°	-121.106710°	
DWR ID	DWR_RD2091_01_f_2017_24					
Comment Code						
Inspector Comment						
Levee Evaluation Comments						
Description:						
Site ID No:132						
Site Designation:DWR_RD2091_01_R_2012_01						
Repair Type: Erosion						
Rating:Area of Concern						
Field Date:6/7/2017						
Notes: Wavewash erosion up to 12" deep at high water mark.

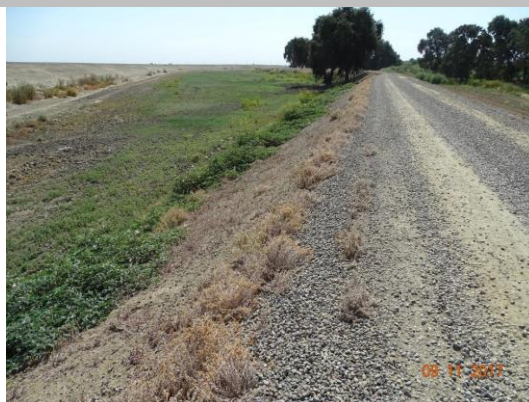
Photo 1 of 1 : SP_2018_RD2091_318_17_20180307_00019.jpg

LM Start	2.00	Rating **	A/W	Issue No.	17
LM End	2.03	Issue Type +	Ma	Location *	LS
Category	Earthen Levee			GPS Latitude/Longitude	
				Start	End
Item	Vegetation			37.526646 °	37.526259 °
				-121.099810 °	-121.099464 °
DWR ID	DWR_RD2091_01_f_2017_17				
Comment Code					
V2 : Remove the wild growth other than native grasses from the levee slopes.					
Inspector Comment

Looking southeast at the landside slope.

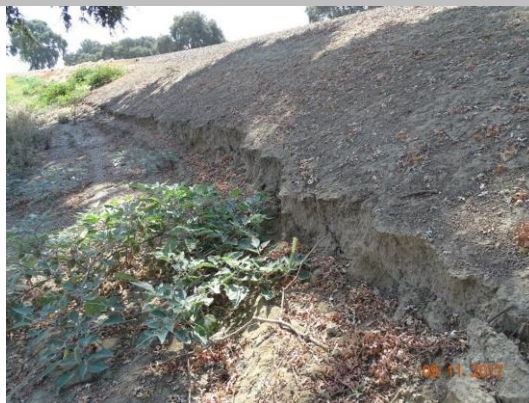
Photo 1 of 1 : SP_2018_RD2091_318_18_20180307_00020.jpg

LM Start	2.05	Rating **	M	Issue No.	18	
LM End	2.06	Issue Type +	Ma	Location *	LS	
Category	Earthen Levee			GPS Latitude/Longitude		
				Start		End
Item	Erosion / Bank Caving			37.526083 °		37.525897 °
				-121.099328 °		-121.099116 °
DWR ID	DWR_RD2091_01_f_2017_18					
Comment Code						
E2 : Schedule repair of erosion site prior to the next inspection.						
Inspector Comment						
Erosion at the landside toe.

Looking southeast at erosion on the toe of the landside slope.

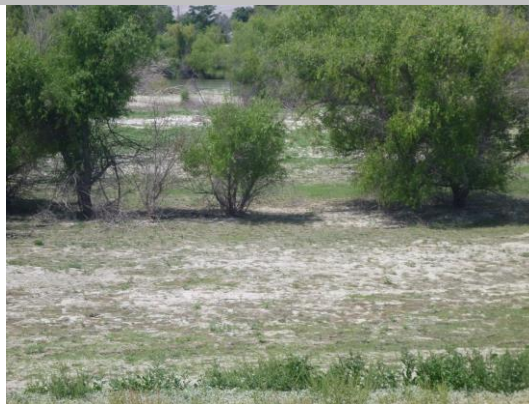
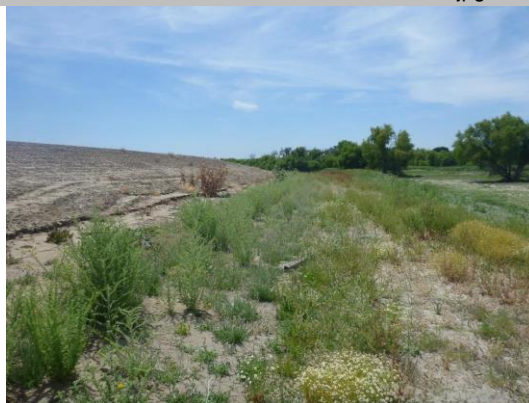
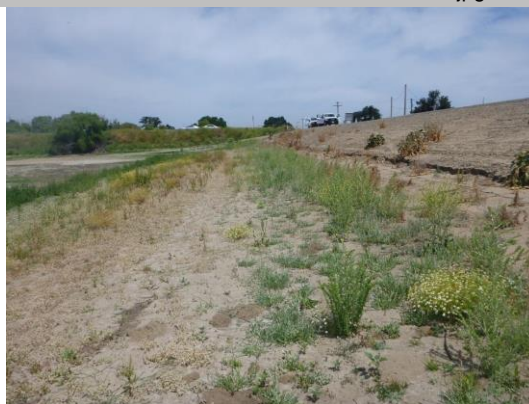
LM Start	4.83	Rating **	A/W	Issue No.	41
LM End	4.83	Issue Type +	Ma	Location *	
Category	Supplemental		GPS Latitude/Longitude		
			Start	End	
Item	2017 Storm Damage		37.494300 °	37.494300 °	
			-121.078300 °	-121.078300 °	
DWR ID	DWR_RD2091_01_f_2017_41				
Comment Code					
Inspector Comment					
Levee Evaluation Comments					
Description:					
Site ID No:117					
Site Designation:LMA-37					
Repair Type: Erosion					
Rating:Area of Concern					
Field Date:6/7/2017					
Notes: Very minor erosion at toe of levee. Depth of erosion is 3" max.

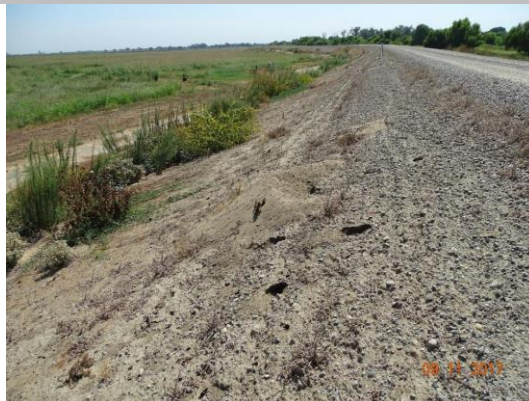
Photo 1 of 4 : SP_2018_RD2091_318_10_20180307_00003.jpg

Looking southeast at landside slope.

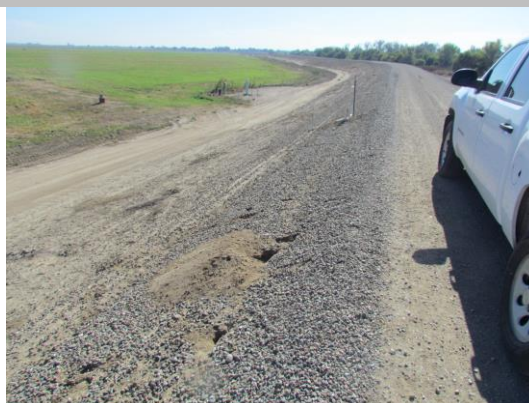
Photo 2 of 4 : SP_2018_RD2091_318_10_20180307_00004.jpg

Looking south at several rodent holes on landward slope.

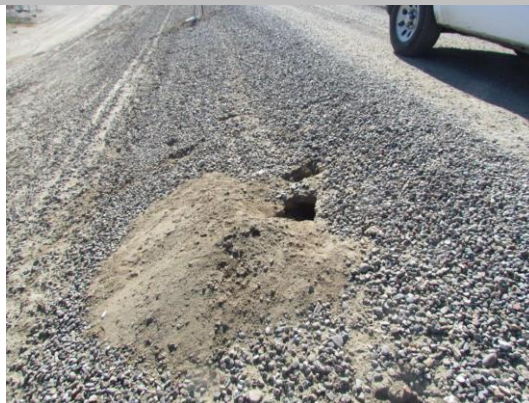
Photo 3 of 4 : SP_2018_RD2091_318_10_20180307_00005.jpg

Looking south at close-up view of rodent holes on landward slope.

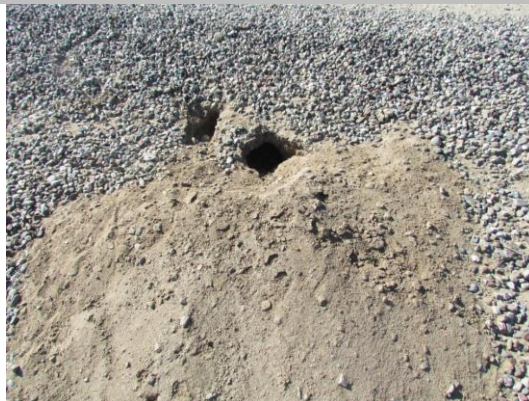
Photo 4 of 4 : SP_2018_RD2091_318_10_20180307_00006.jpg

Looking west at close-up view of rodent holes on landward slope.

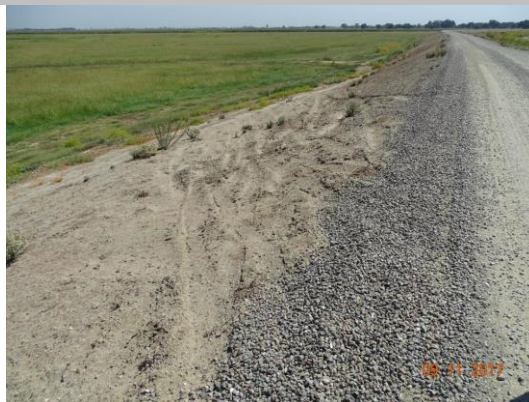
Photo 1 of 2 : SP_2018_RD2091_318_13_20180307_00010.jpg

LM Start	5.20	Rating **	A/W	Issue No.	13
LM End	5.20	Issue Type +	Ma	Location *	LS
Category	Earthen Levee			GPS Latitude/Longitude	
				Start	End
Item	Slope Stability			37.490756 °	37.490756 °
				-121.073410 °	-121.073410 °
DWR ID	DWR_RD2091_01_f_2016_13				
Comment Code					
S3 : Repair the levee slope damaged by vehicle traffic and prevent access where possible.					
Inspector Comment					
Vehicle traffic damaging slope on landward slope.

Looking southeast at the landside slope.

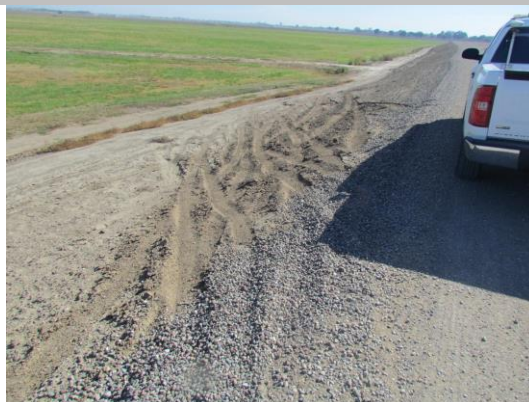
Photo 2 of 2 : SP_2018_RD2091_318_13_20180307_00011.jpg

Looking at damage on landside slope.

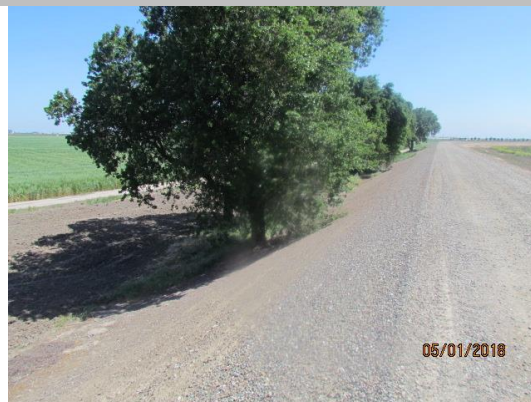
Photo 1 of 1 : SP_2018_RD2091_318_12_20180503_00050.jpg

Looking southeast at untrimmed tree at landward toe. (Spring 2018)

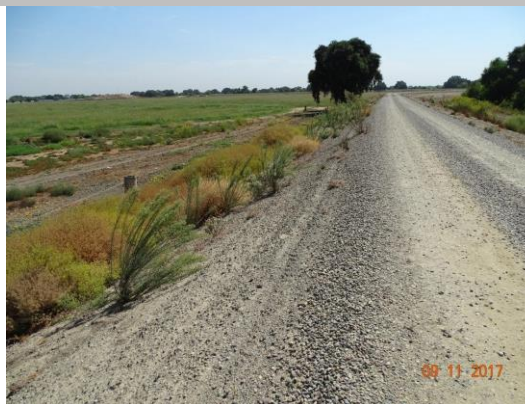
Photo 1 of 1 : SP_2018_RD2091_318_36_20180307_00031.jpg

Looking southeast at landside slope.

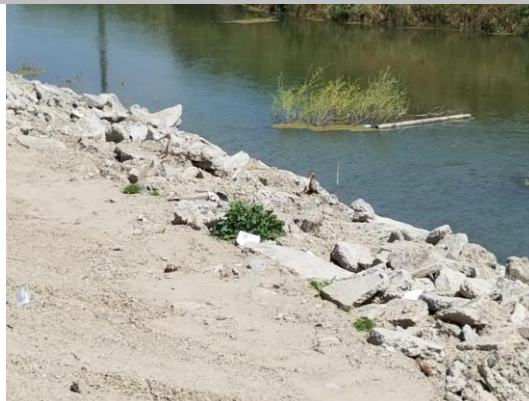
Photo 1 of 3 : SP_2018_RD2091_318_8_20180307_00001.jpg

LM Start	7.42	Rating **	U	Issue No.	8
LM End	7.45	Issue Type +	Ma	Location *	LS
Category	Earthen Levee			GPS Latitude/Longitude	
				Start	End
Item	Erosion / Bank Caving			37.479308 °	37.478998 °
				-121.044708 °	-121.044660 °
DWR ID	DWR_RD2091_01_s_2017_8				
Comment Code					
E2 : Schedule repair of erosion site prior to the next inspection.					
Inspector Comment					
Repaired area with concrete containing rebar. Need to remove rebar.

Looking northeast at concrete rubble with rebar at landward toe next to canal.

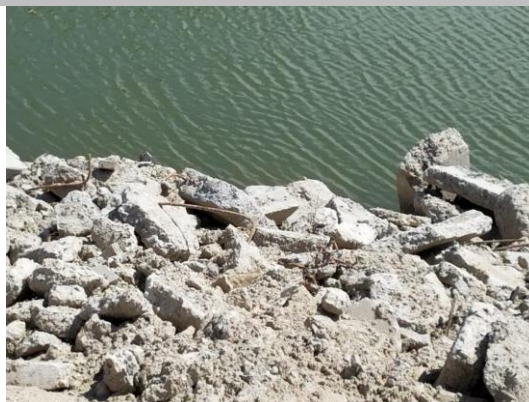
Photo 2 of 3 : SP_2018_RD2091_318_8_20180307_00002.jpg

Looking east at concrete rubble with rebar at landward toe next to canal.

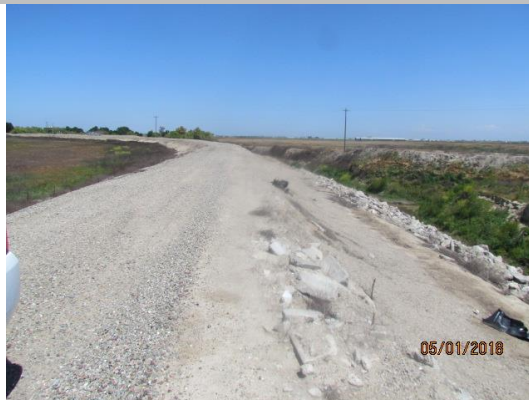
Photo 3 of 3 : SP_2018_RD2091_318_8_20180503_00051.jpg

Looking east at repaired site on waterward slope and toe. (Spring 2018)

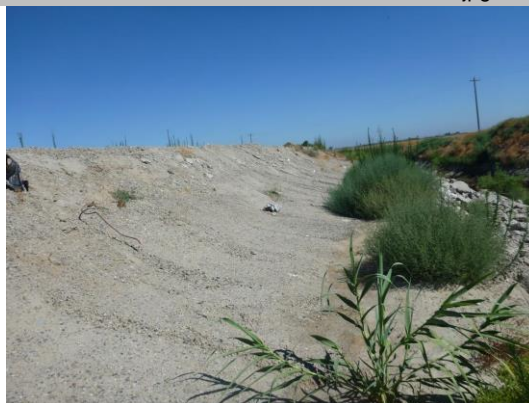
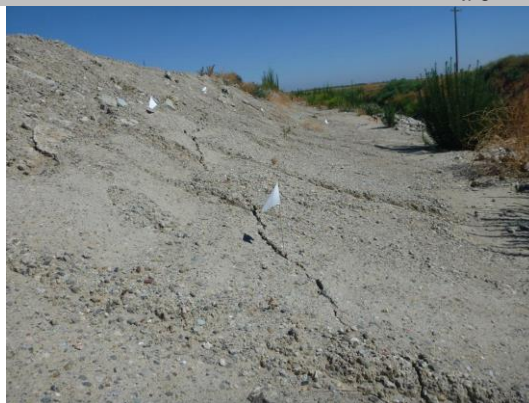
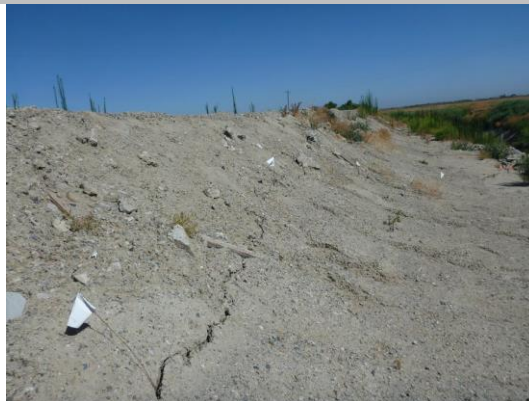
LM Start	7.45	Rating **	A/W	Issue No.	23
LM End	7.45	Issue Type +	Ma	Location *	
Category	Supplemental			GPS Latitude/Longitude	
				Start	End
Item	2017 Storm Damage			37.479000 °	37.479000 °
				-121.044000 °	-121.040000 °
DWR ID	DWR_RD2091_01_f_2017_23				
Comment Code					
Inspector Comment					
Levee Evaluation Comments					
Description:Sloughing at Mile 7.59 of the San Joaquin River					
Site ID No:473					
Site Designation:LMA-300					
Repair Type: Erosion					
Rating:Area of Concern					
Field Date:7/20/2017					
Notes: Concrete rubble was installed here during the storms after noticing cracks and sloughing. It has rebar sticking out and needs to be replaced with clean rip rap. Responsibility is grey here because TID maintains channel and placed concrete during storm.
